8.0 Gunnison, Colorado, Disposal Site

The Gunnison, Colorado, Uranium Mill Tailings Radiation Control Act (UMTRCA) Title I Disposal Site, was inspected on June 3, 2008. The disposal cell and all associated surface water diversion and drainage structures were in excellent condition and functioning as designed. Six riprap test areas on the cell apron and diversion ditches were visually inspected; no apparent rock degradation was noted when compared to previous photos. A deep-rooted shrub was removed from the top of the disposal cell. The perimeter fence was repaired at several locations from damage caused by significant snow accumulations during the winter. Several damaged and missing perimeter signs were replaced. Snowmelt runoff resulted in minor erosion near the southeast corner of the site; repair is not warranted at this time. No other maintenance needs or cause for a follow-up or contingency inspection was identified.

Figure 8-1. 2008 Annual Compliance Drawing for the Gunnison Disposal Site

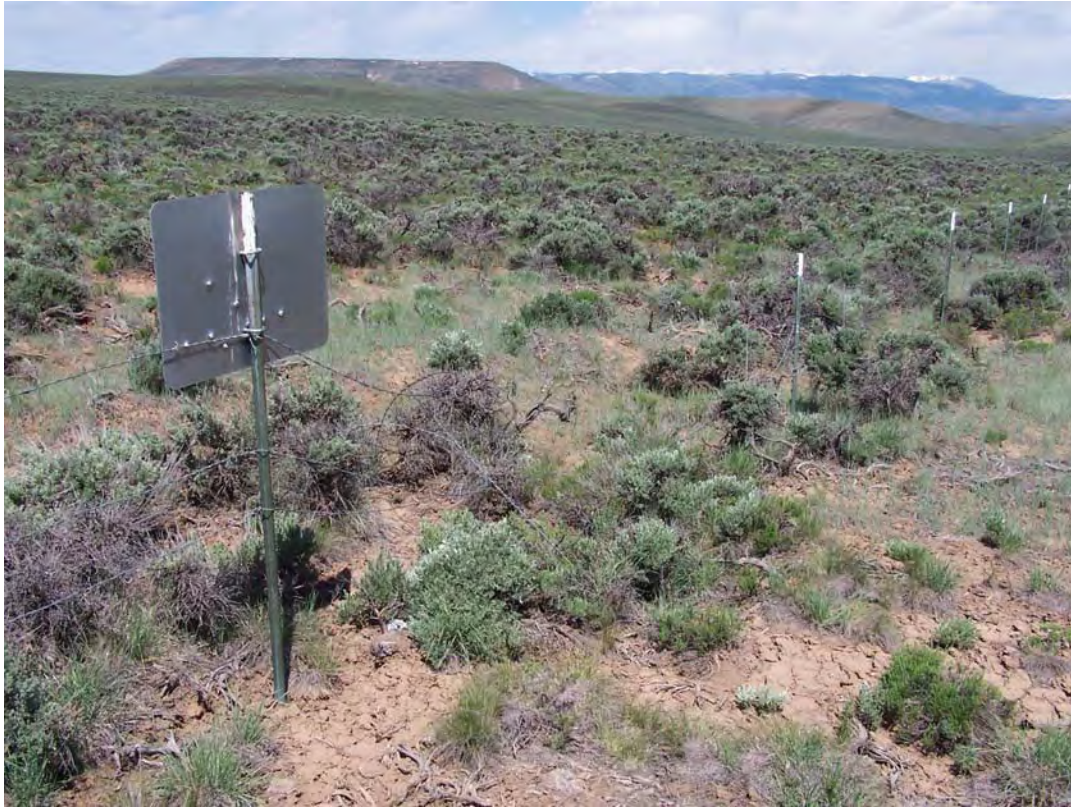
8A A three-strand, barbed-wire fence delineates the site; most of it is set along the property boundary. Fence strands were broken at several locations along the north and west sides of the site (PL–1). This damage is attributed to the above-average snow accumulation that occurred during the past winter. The broken strands were repaired on June 19, 2008.

GUN 6/2008. PL-1. Broken fence strands near perimeter sign P8.

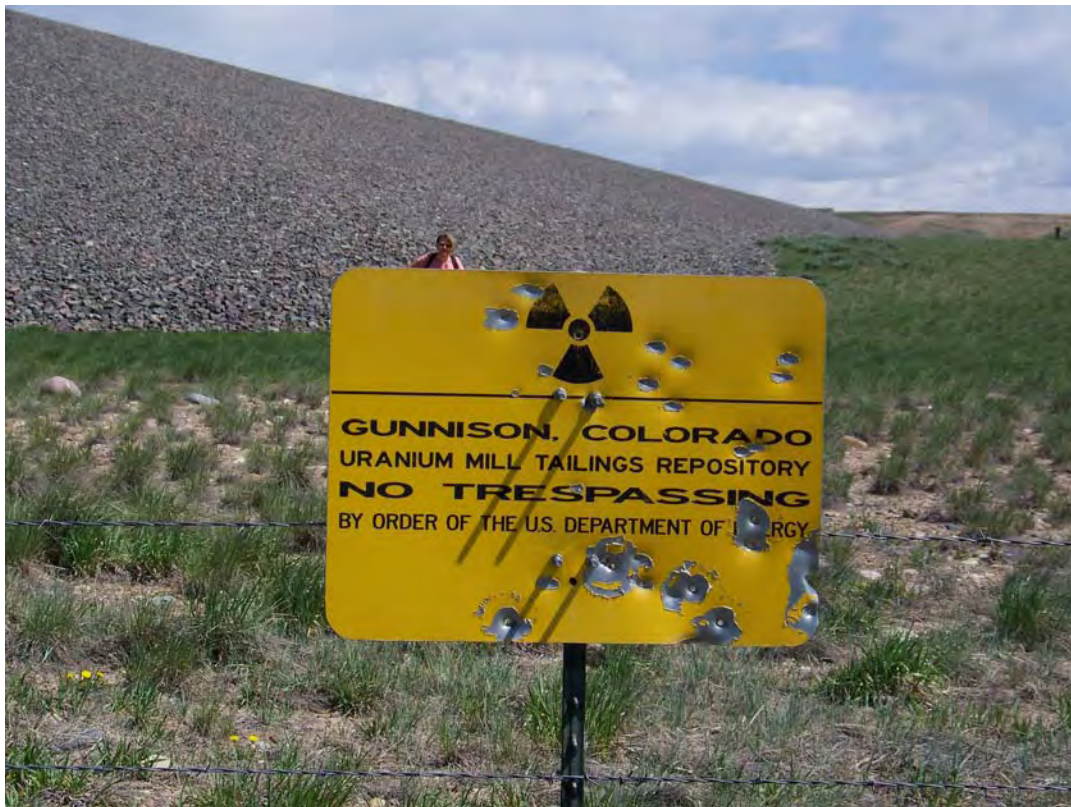
8B The entrance sign, located at the south entrance gate, is in good condition. Forty-five perimeter signs are bolted to the perimeter fence posts. Nine perimeter signs (P2, P7, P8, P9, P10, P11, P12, P13, and P42) were heavily damaged by bullets (PL–2), and one perimeter sign (P38) was missing; new signs were installed at these locations on June 19, 2008. The remaining signs were in good condition.

GUN 6/2008. PL-2. Damaged perimeter sign P42.

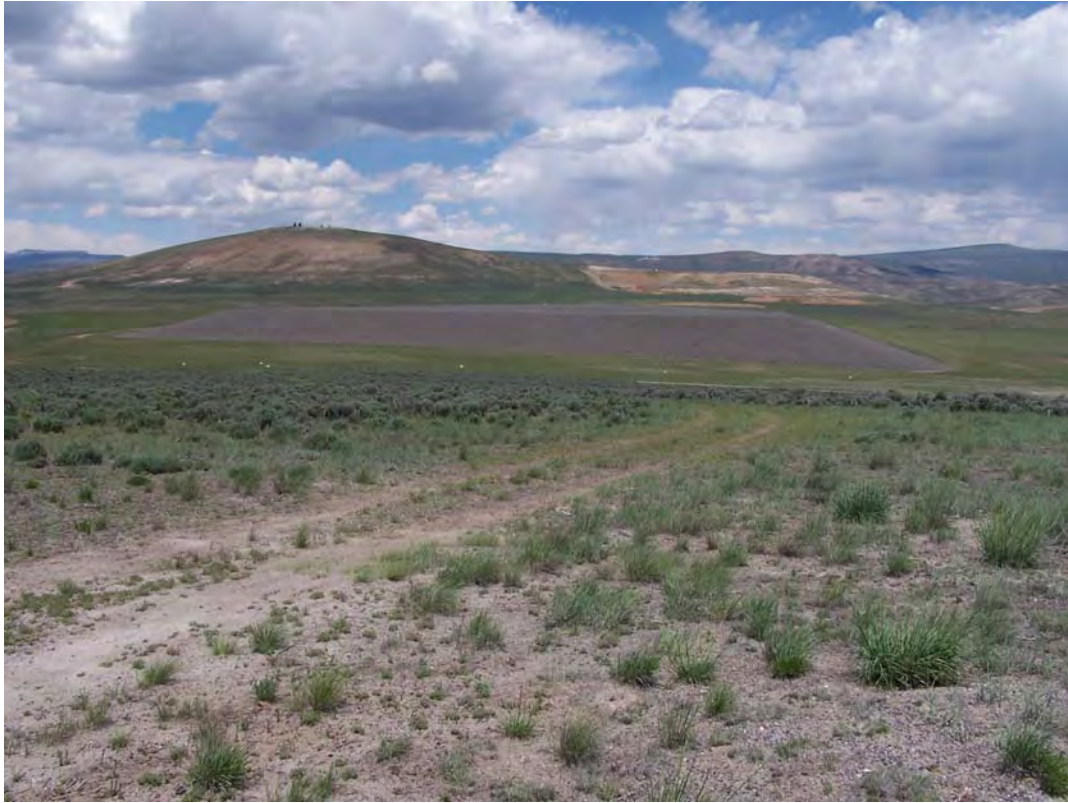
8C **Top of Disposal Cell**—The top of the disposal cell was in excellent condition. There was no evidence of erosion, settling, slumping, or rock degradation (PL-3). Several isolated patches of grass were randomly distributed over the disposal cell cover; however, these shallow-rooted plants are not a cause for concern. One small deep-rooted shrub was found on the cell top and was cut and treated with herbicide in accordance with the LTSP. Many small indentations continue to be present on the cell cover. The indentations, with dimensions up to 4 inches across and up to 4 inches deep, appear to have been caused by pronghorn antelope. None of the indentations penetrate into the bedding layer under the rock cover, and they are not a cause for concern.

GUN 6/2008. PL-3. Disposal cell viewed from the south.

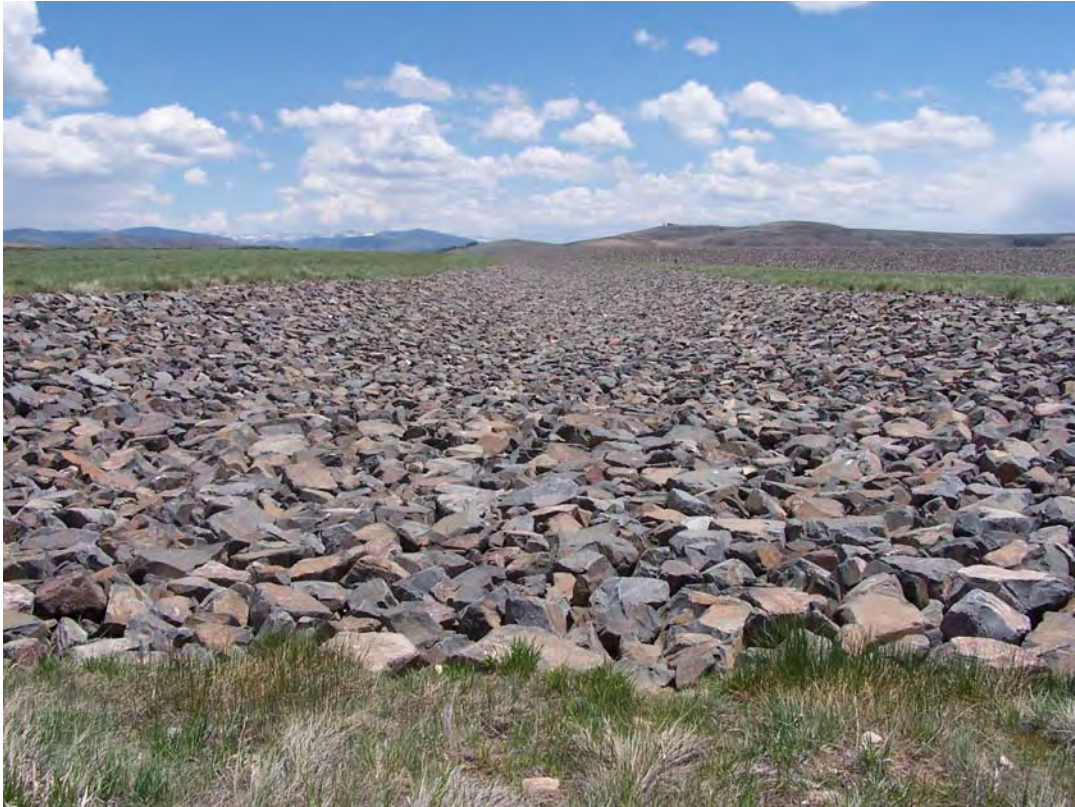
Side Slopes, Apron, and Diversion Ditches—The riprap-covered side slopes, apron, and diversion ditches were in excellent condition (PL-4 and PL-5). No evidence of slumping, settling, rock degradation, or encroachment of vegetation was observed.

GUN 6/2008. PL-5. West diversion channel.

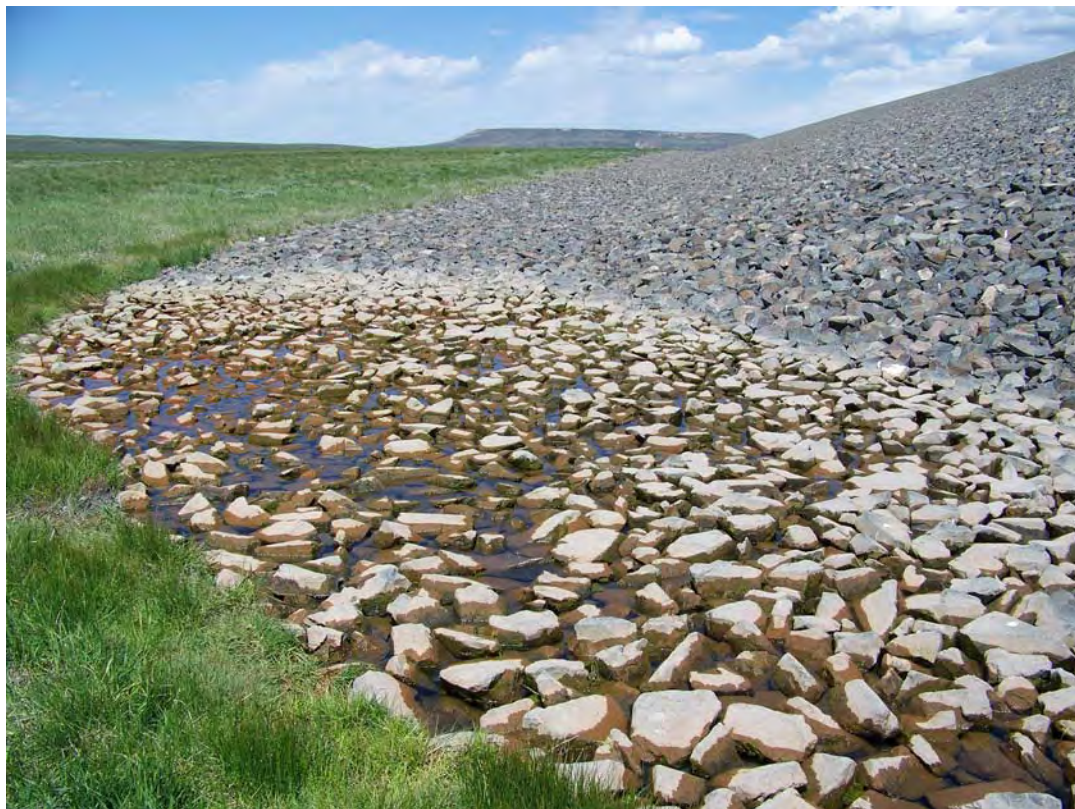
At the southeast corner of the cell apron, water draining from the cell occasionally ponds in a low-lying area along the edge of the riprap. The riparian-type vegetation that has become established in this area indicates that the area retains moisture much of the time. Water collection in this area does not pose a problem because the cell is designed to drain to the southeast, and any water that ponds is below the elevation of the entombed tailings material. Ponded water was present in the apron (PL-6), and the soil in this area was moist at the time of the inspection.

GUN 6/2008. PL-6. Ponded water at the southeast corner of the disposal cell.

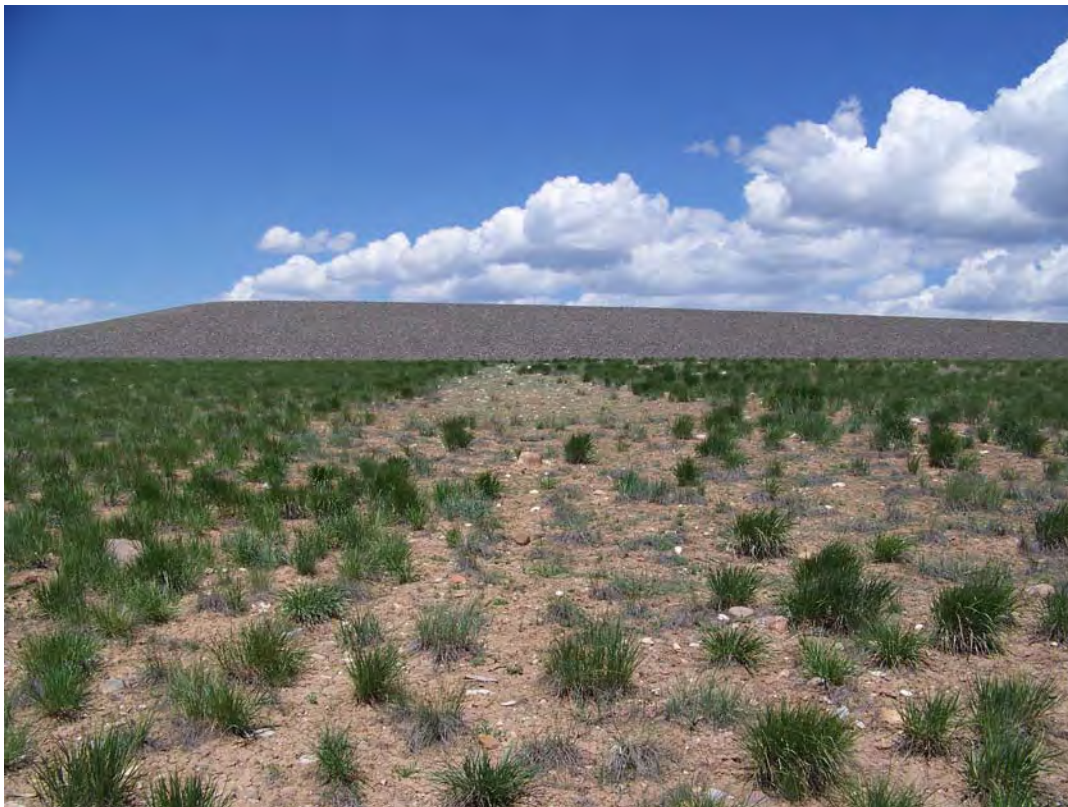
Area Between the Disposal Cell and the Site Boundary—Reclaimed and undisturbed areas occur between the disposal cell and the site perimeter. Both types of areas are in excellent condition. In general, reclaimed areas have good vegetation coverage, mostly grass. However, there are several small areas of sparse vegetation attributed to poor soil conditions (PL-7). As expected, shrubs and forbs are much less abundant and less diverse in reclaimed areas than they are in undisturbed areas. Overall, however, the vegetation at the site is healthy following a winter of above-average snowfall.

GUN 6/2008. PL-7. Poorly vegetated area near the east side of the disposal cell.
